Confidential Inspection Report

[REDACTED]
San Carlos, Sonora 85506

[REDACTED]
INSPECTED ON:
Monday, January 16, 2023

Inspector, Vincent Phillips
Punchlist Home Inspections

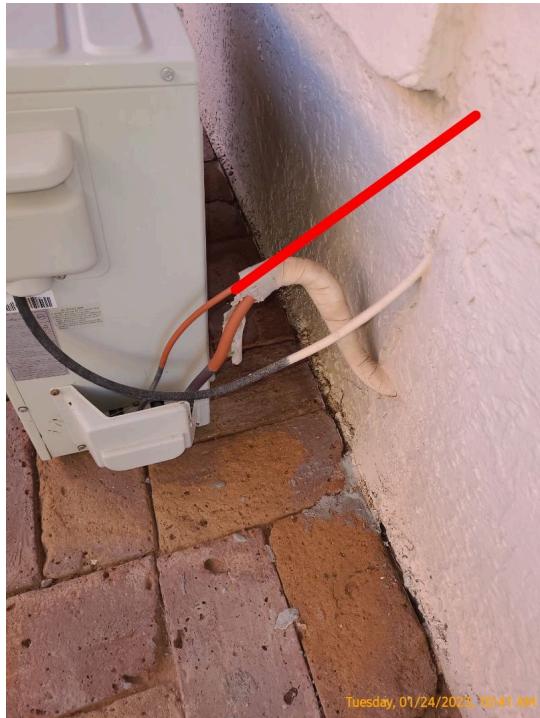
UPG 18: The accessible refrigerant lines appear to be in good condition except as noted below: Insulation of 2nd bdrm refrigerant line is incomplete.

front bdrm missing insulation

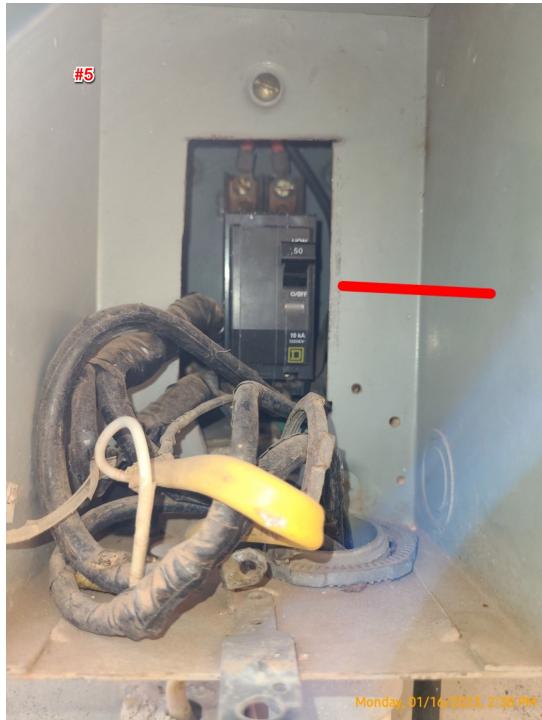
improper electrical line covering here!! Unknown destination!!

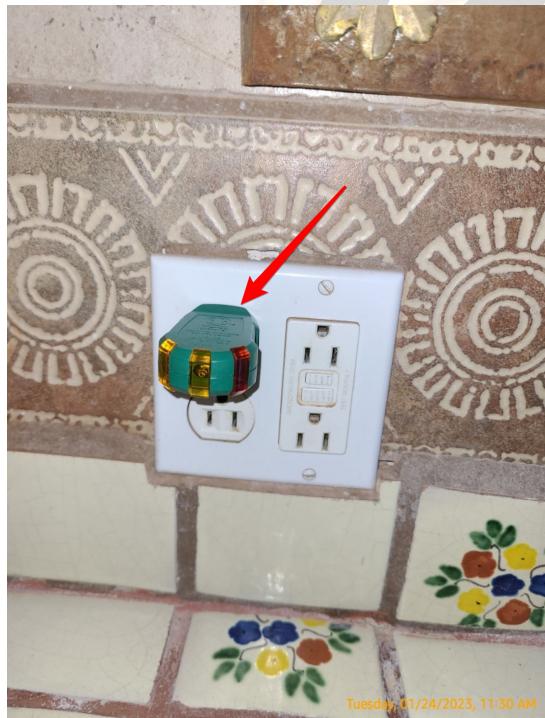
UPG 61: Based upon our inspection of a representative number, the receptacles were generally found to be in serviceable condition and operating properly, with exceptions noted here. The master bathroom top left electrical outlet is without power. Services of an electrician are recommended to remedy.

No power to this top left outlet:GFCI is functional

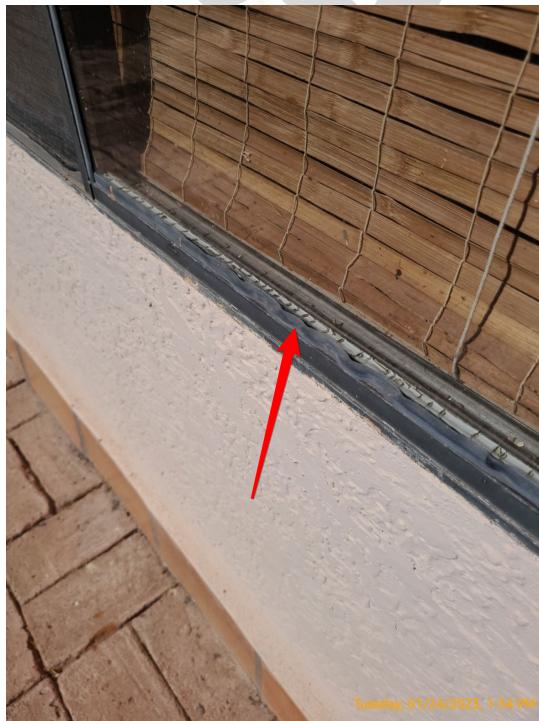
UPG 65: The windows tested appear to be properly installed and generally in serviceable condition, with exceptions noted below or elsewhere in this report.

living room window outside bottom

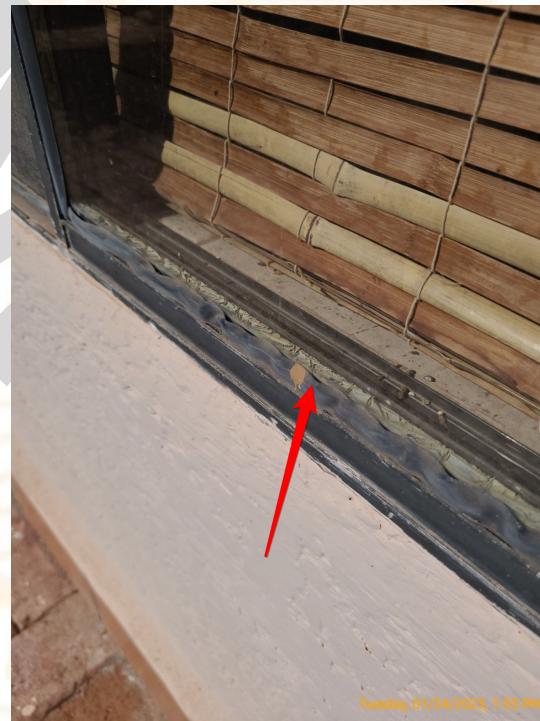
living room window #2 outside bottom

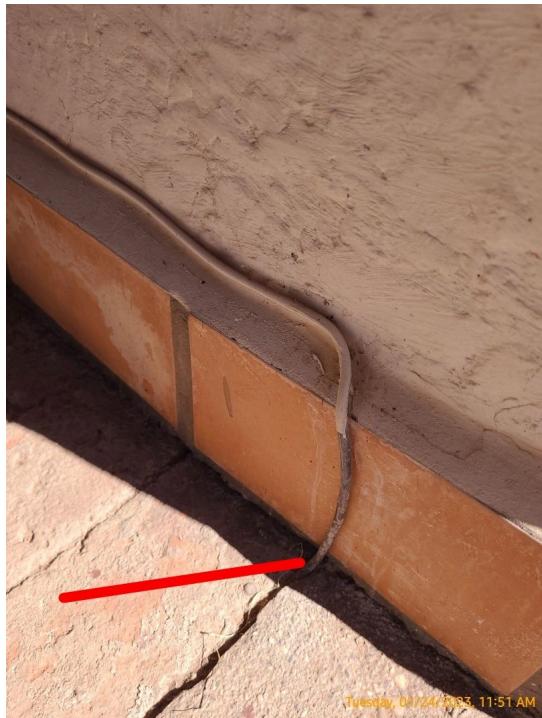
76: The gas line at the LP gas tank has been installed in a substandard manner. We recommend it be repaired or replaced as it is subject to corrosion AND inadvertent damage by passersby. Consult a professional plumber

WARN 78: For attention to the condition(s) noted above, we recommend the advice and services of a licensed plumbing contractor.

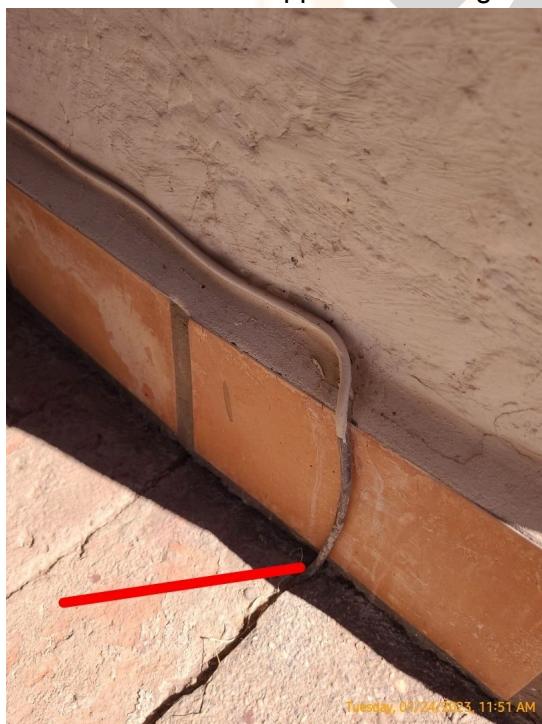
77: The exterior gas piping lacks proper protection where it is exposed and/or at the buried sections. We recommend that an approved coating or wrapping be installed.

Exposed gas line adjacent to front door

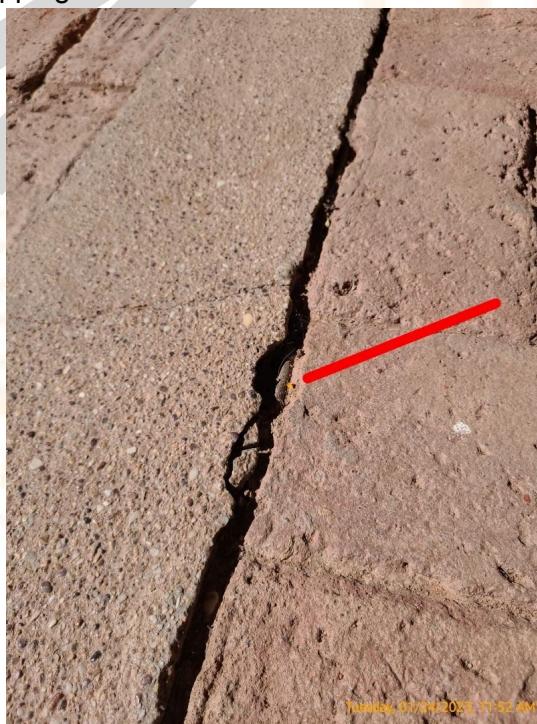
gas line visible in crack

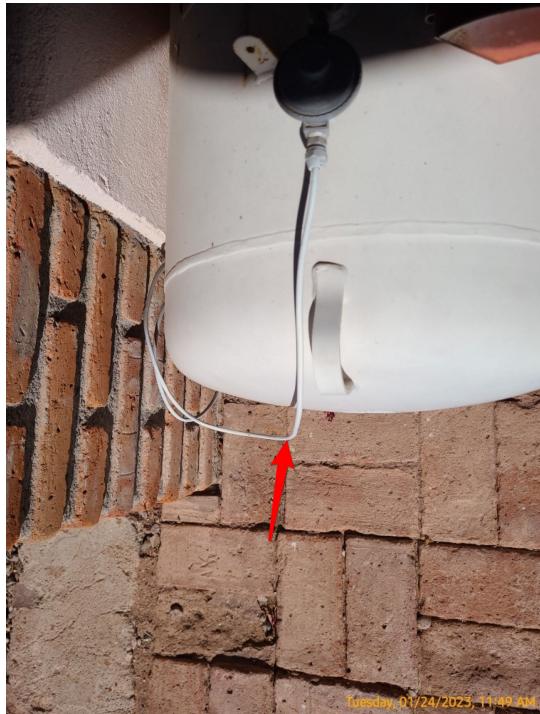
Unprotected gas line

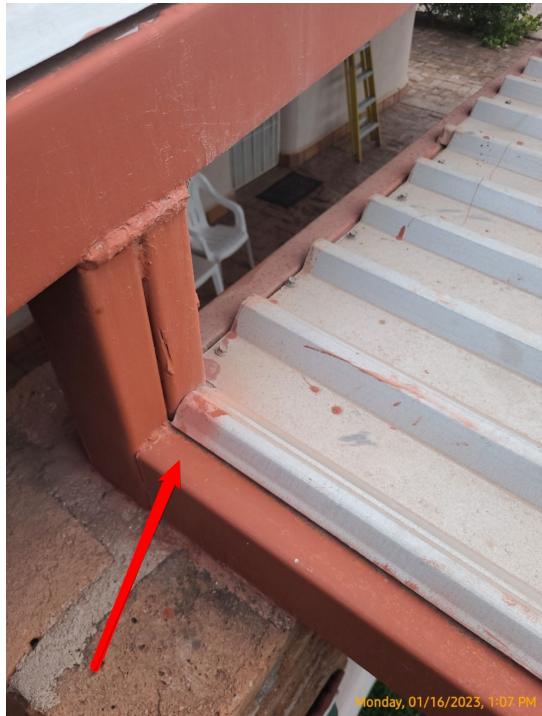
UPG 81: The metal roof is in serviceable condition with minor exceptions. Attention to the items listed, together with routine maintenance, will keep it functional and maximize its expected useful life. Roof has been coated with what appears to be an elastomeric coating or white paint and has been done somewhat recently. There are areas at front porch and the rear porch where gaps are present when the sheet metal roofing comes into contact with main structure. In essence there are no flashings attached to main building and/or the sheet metal does not span entire gap. See pics.

front porch north edge does not cover metal frame

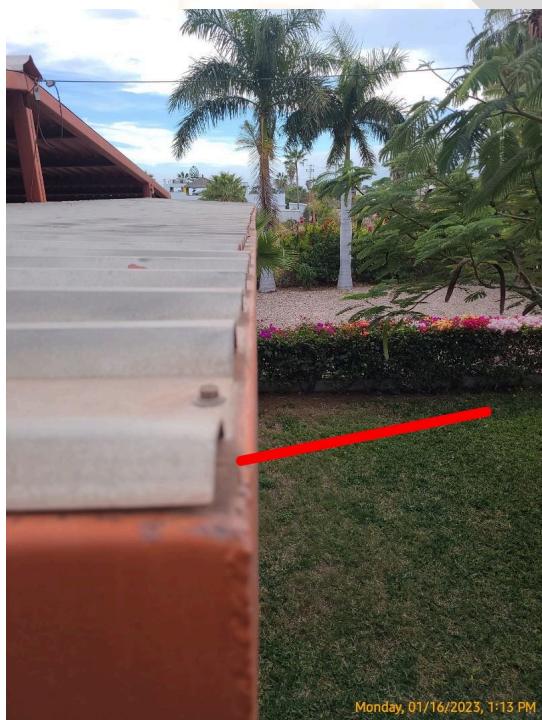
front porch no drip edge

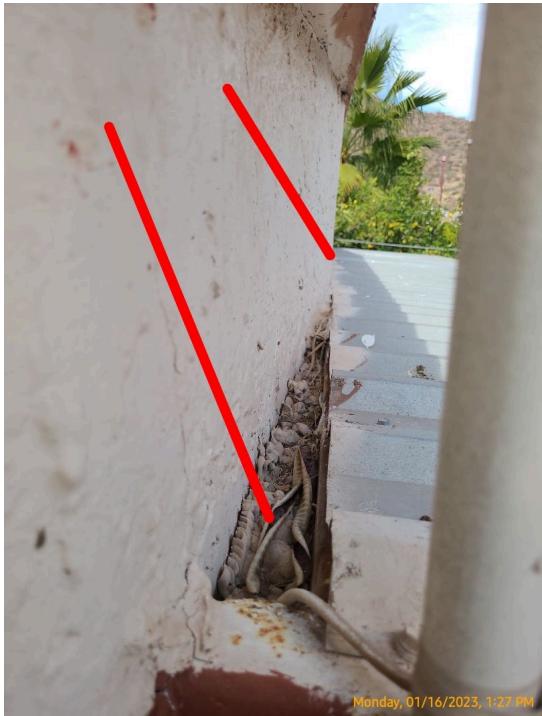
back porch no flashing/shorted

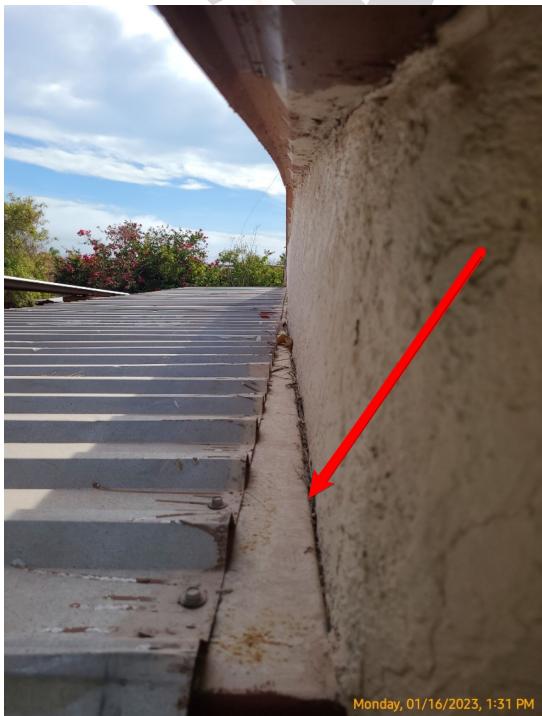
back porch north end no flashing/shorted/top view

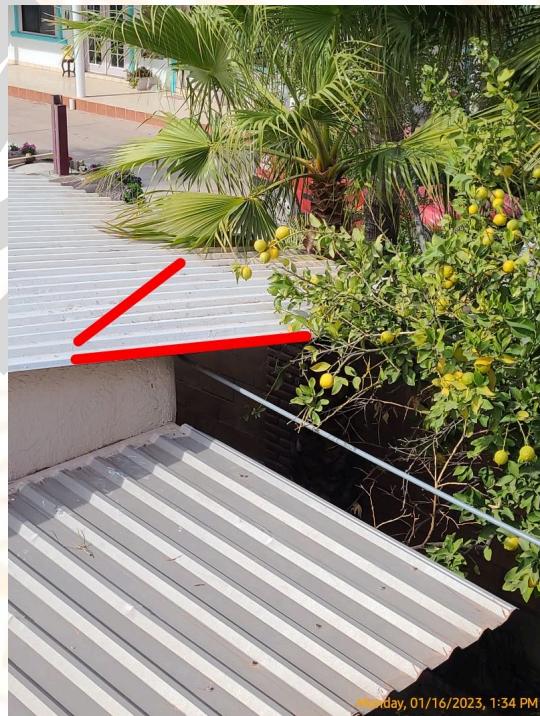
northeast corner: trees contact roof

95: We recommend the trees overhanging the roof be trimmed to prevent damage of the roofing surface, and allow free flow of roof runoff. NE corner is only area observed to have contact with vegetation. Palm tree and citrus tree. See Pics

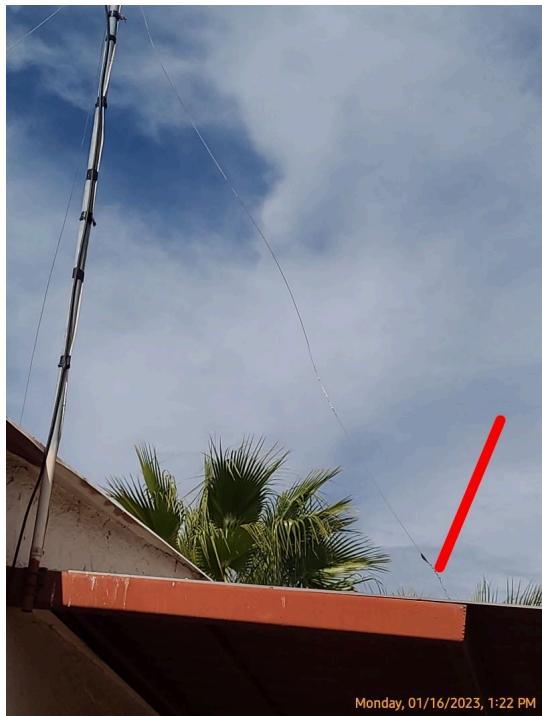
UPG 82: The TV antenna appears to be in serviceable condition but the guy wires are not anchored securely to the roof. A simple repair now will save a much more expensive replacement of a fallen antenna.

Guy wire not tight

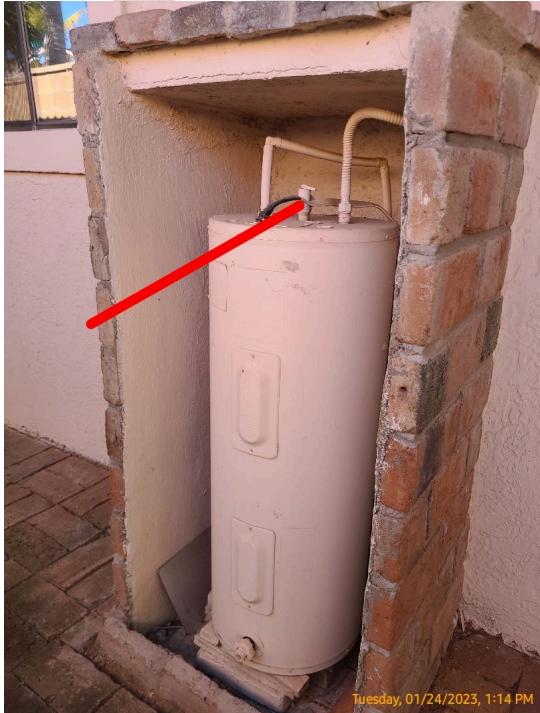
UPG 86: The temperature and pressure relief valve lacks a discharge pipe. We recommend the installation of approved piping to an approved location away from foundation. This is an optional improvement and was not required during original installation

exposed no drain tube for valve

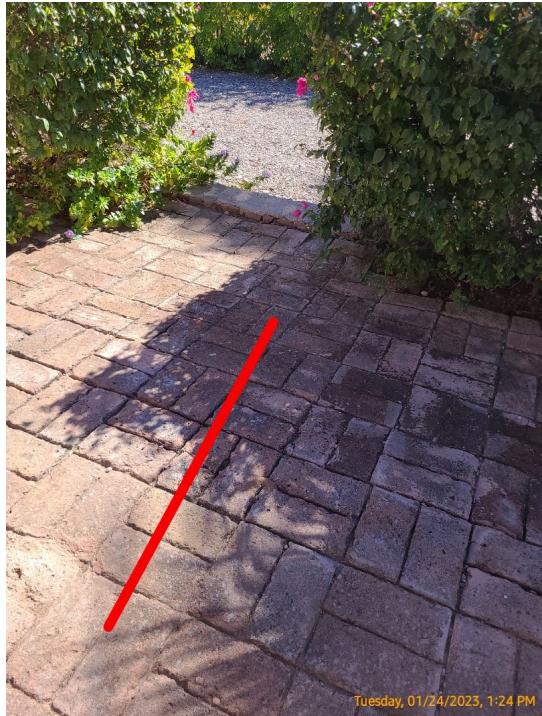
UPG 88: Site grading: Sloped away from structure. However, I observed two areas on patio shows area of moisture accumulation during rainfall. Low spots are at a lower grade and are located away from exterior walls so as not to cause problems with the structure. See pics.

SW corner patio

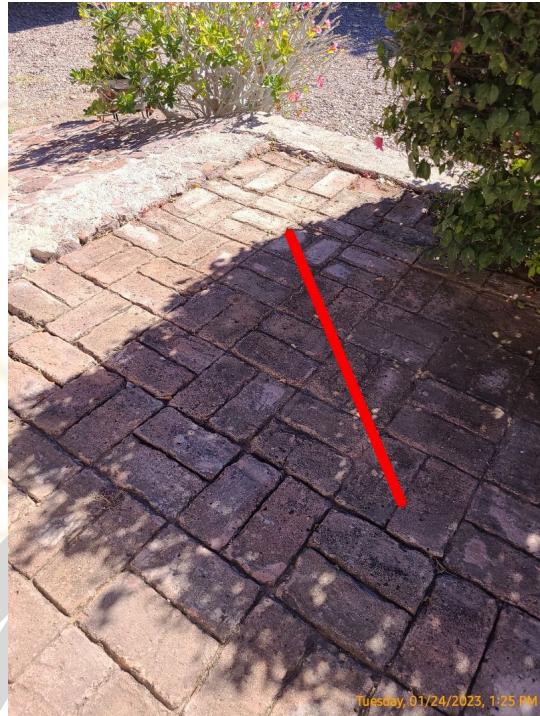
SE corner patio

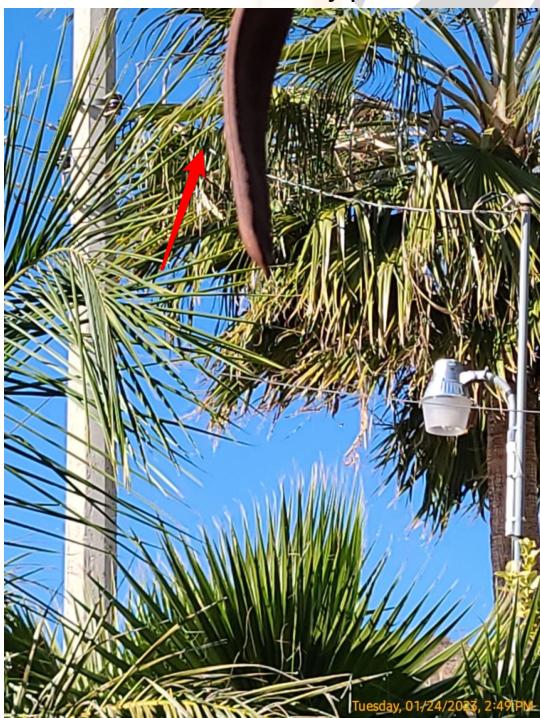
91: The overhead service wires are deflected by trees. We recommend the trees be trimmed clear of the wires or the service be reconfigured. To reduce shock hazard during this procedure, the work should be coordinated with the utility provider.

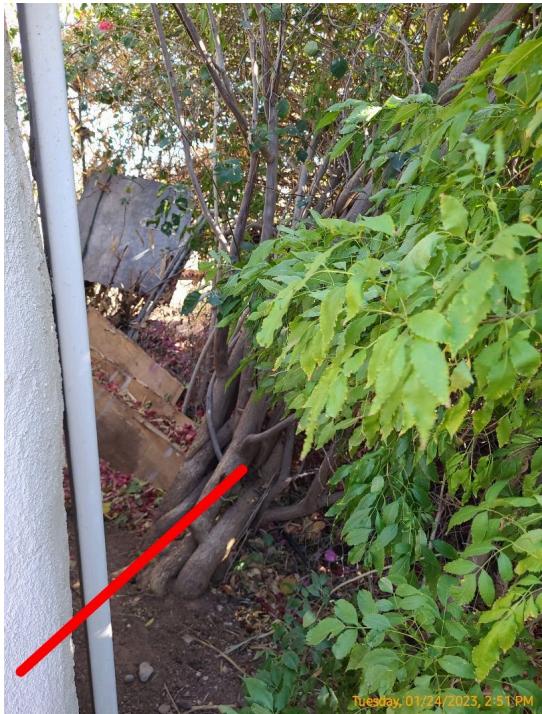
Bougainvillea tree is overgrown and pushing down the fencing on the south fenceline adjacent to outbuilding near south east corner of lot.

behind shed

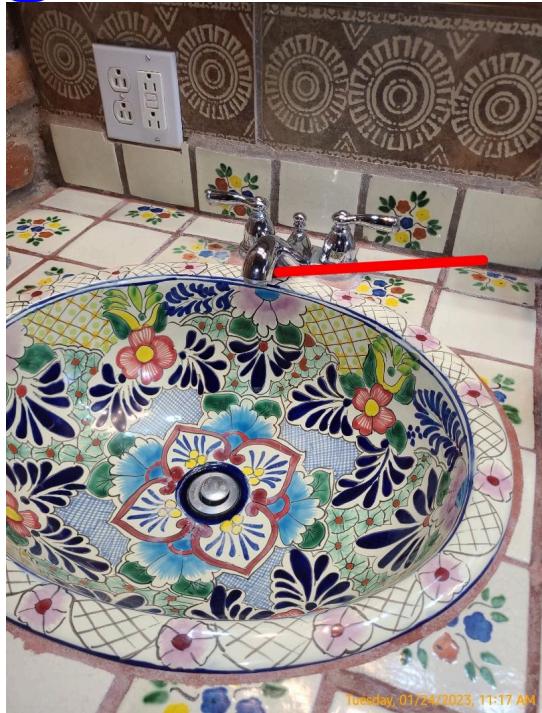
UPG 97: The mstr bdrm faucet is dripping slowly. We recommend that it be repaired or replaced.

slow drip

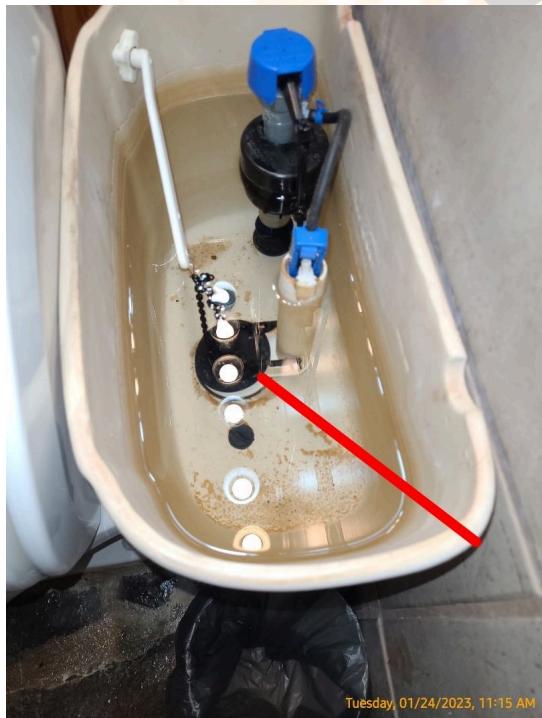
UPG 98: Location: master bathroom. The toilet flapper slowly leaks water into the bowl. We recommend that it be repaired or replaced.

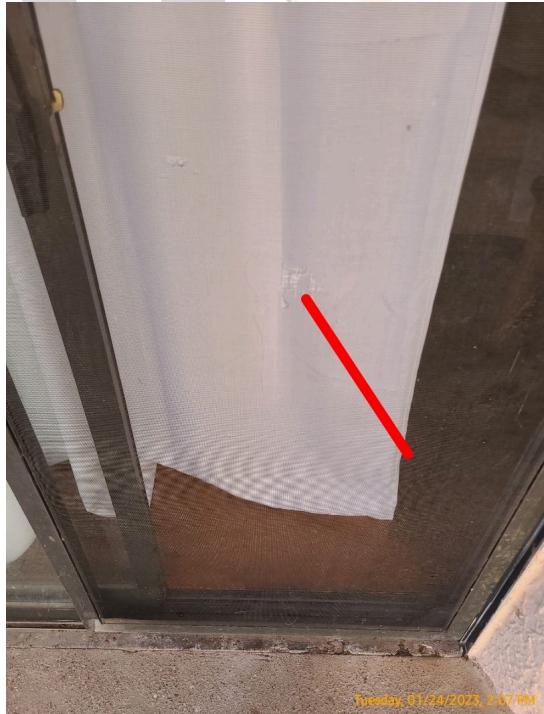
UPG 101: Master bedroom Sliding door screen has a small hole. We recommend it be repaired or replaced.

Mstr bdrm screen

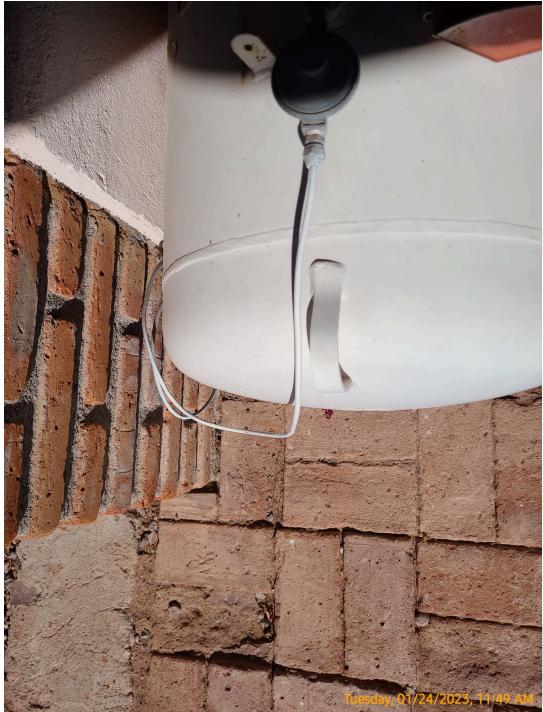
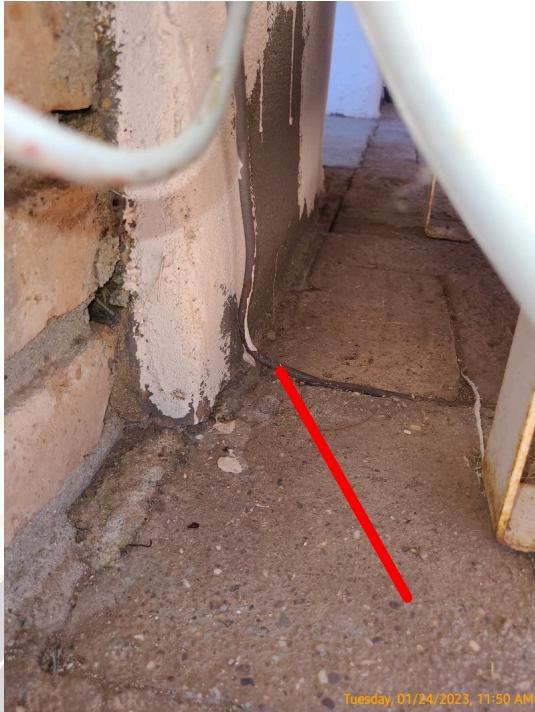
106: The gas connector is copper tubing. Copper is no longer approved for this use because it is prone to deterioration, which causes clogging of the control valve. We recommend it be replaced with an approved connector. The coil or tubing is exposed and not protected from collision or properly encased in an approved line with protective insulation for today's standards. Recommend qualified plumber to upgrade to safely protect

buried line. unprotected from corrosion

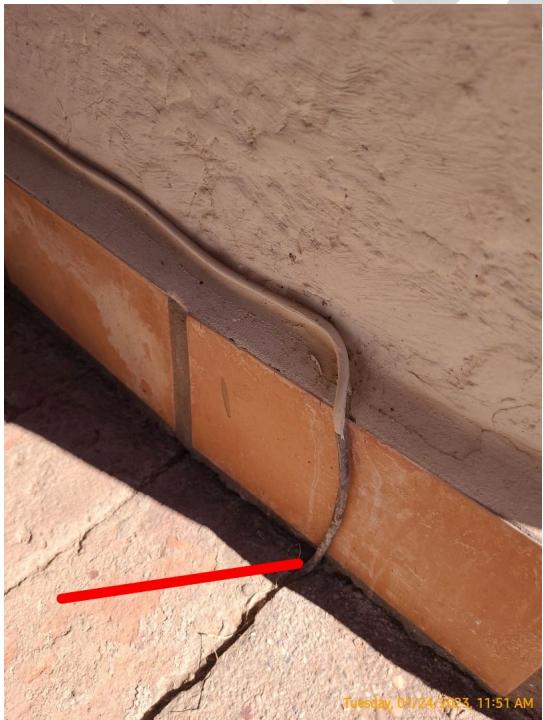
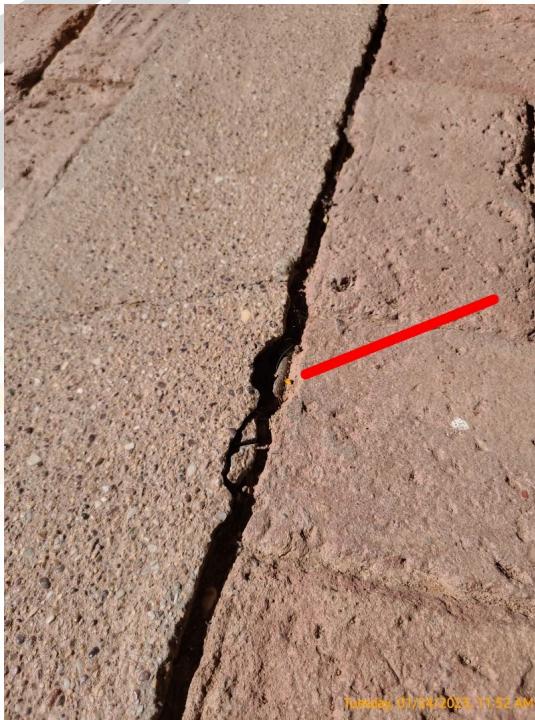
exposed line walkway

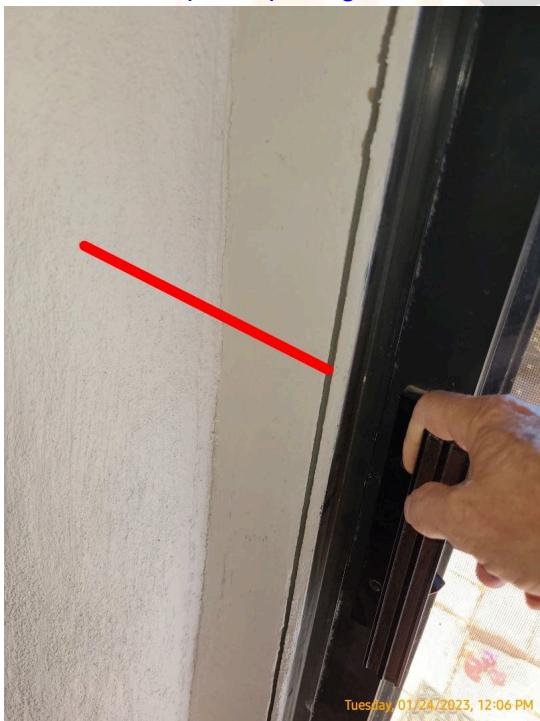
112: The kitchen sliding door door frame is not anchored properly. When door is locked the frame flexes with the attempted opening of slider. We recommend it be repaired or replaced.

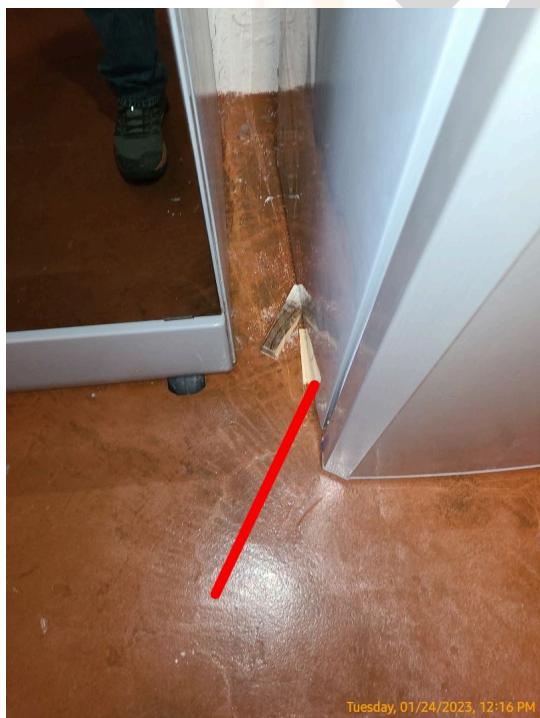
Refrigerator is missing of the adjustable feet on the front left location. It is currently on a wood block.

adjusting leg missing/inoperable

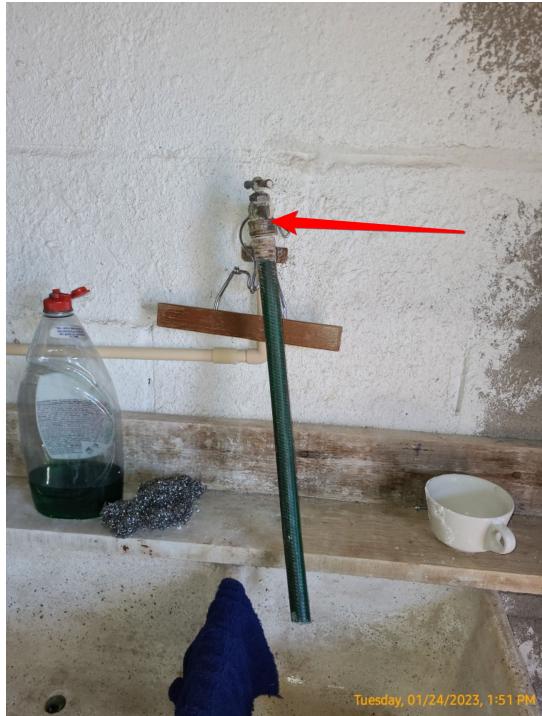
UPG 119: ****Note**:** There is no hot water available in the detached laundry room.** The utility sink shutoff is leaking slowly. See pic. We recommend it be repaired or replaced.

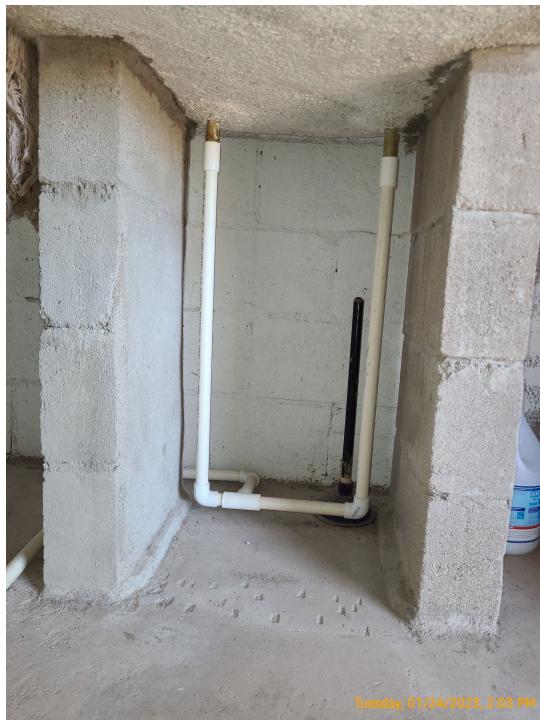
120: The drain trap is non existent. The drain is PVC plastic with no venting.

121: There is no drain trap for the utility sink.

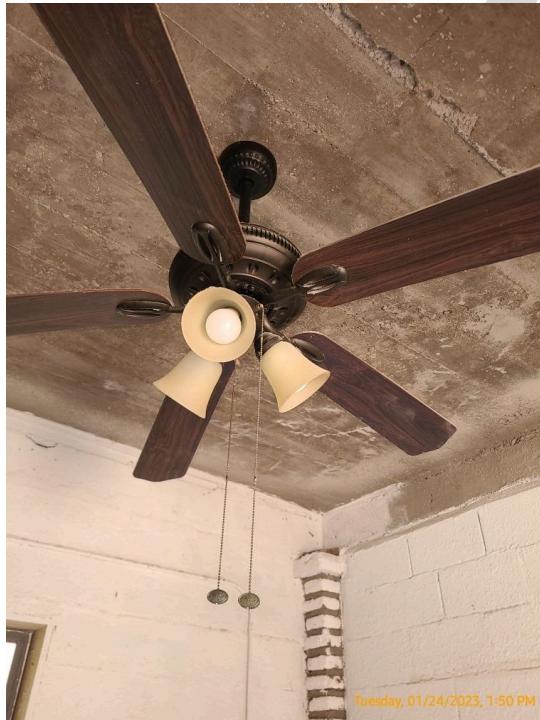
122: The ceiling fan/light is not working. The bulb may have burned out. We recommend that the bulb be tested and replaced, if necessary, and the proper operation of the fixture be verified.

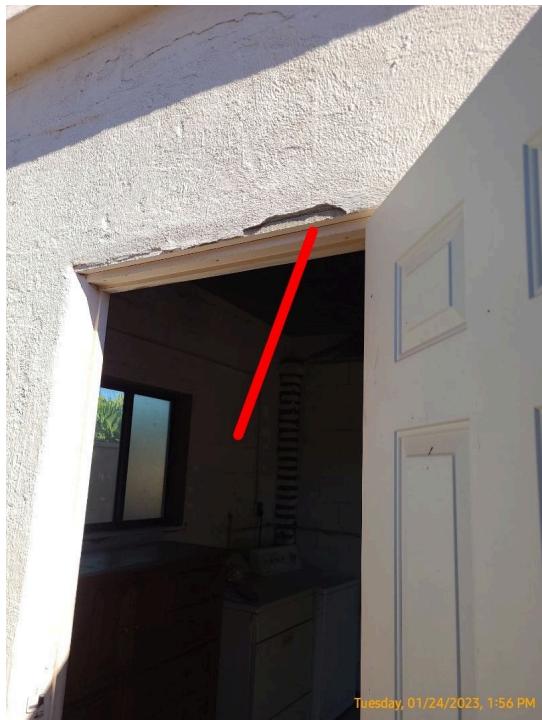
123: Door frame has stucco missing at top edge.

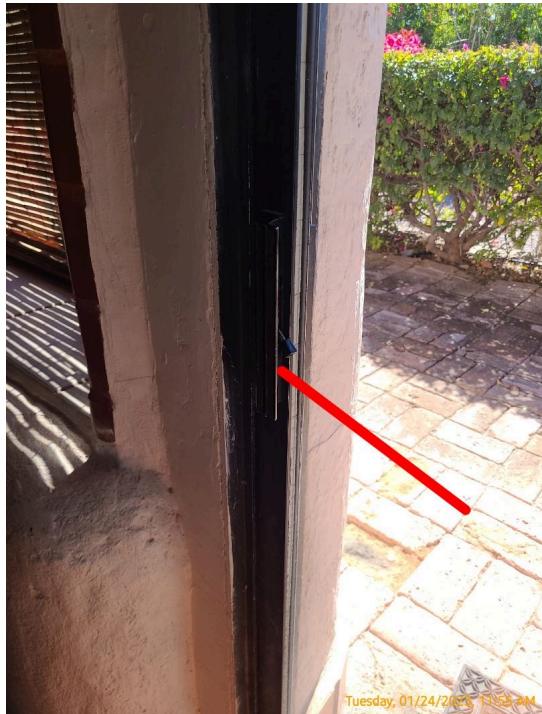
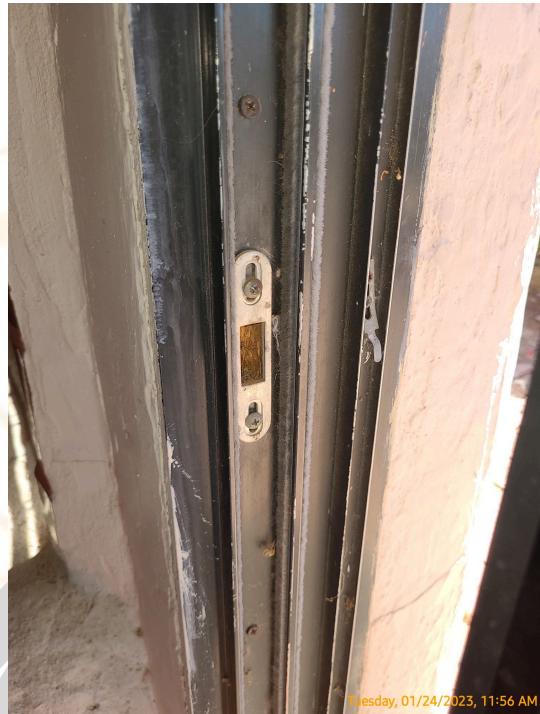
126: The door doesn't latch. We recommend minor adjustments to the hardware to restore proper function.

latch and mechanism doesn't match up

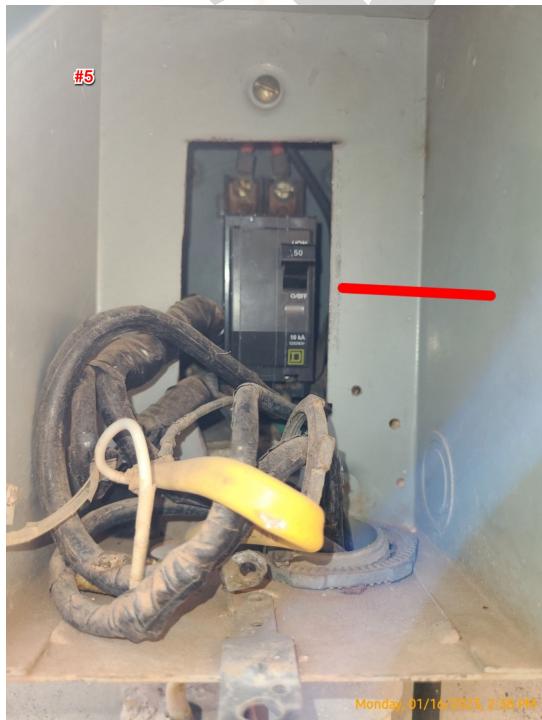
improper electrical line covering here!! Unknown destination!!
