Confidential Inspection Report

[REDACTED]
San Carlos, Sonora 85506

[REDACTED]
INSPECTED ON:
Monday, January 16, 2023

Inspector, Vincent Phillips
Punchlist Home Inspections

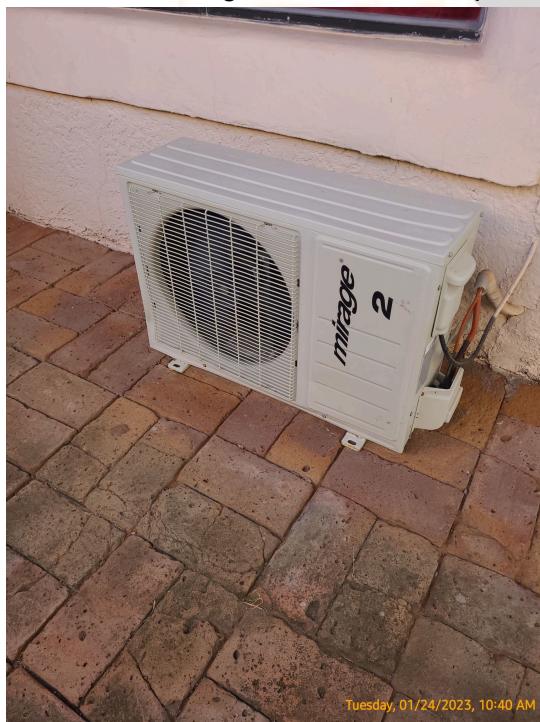
front bedroom

UPG 18: The accessible refrigerant lines appear to be in good condition except as noted below: Insulation of 2nd bdrm refrigerant line is incomplete.

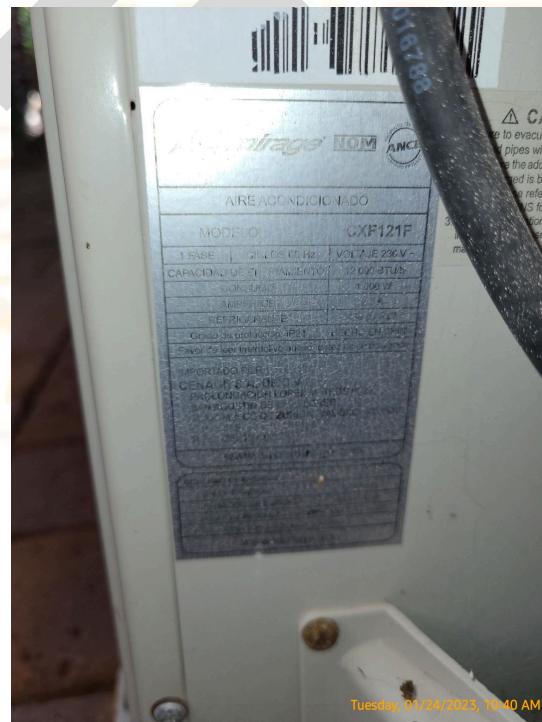
serial # faded ext condensor

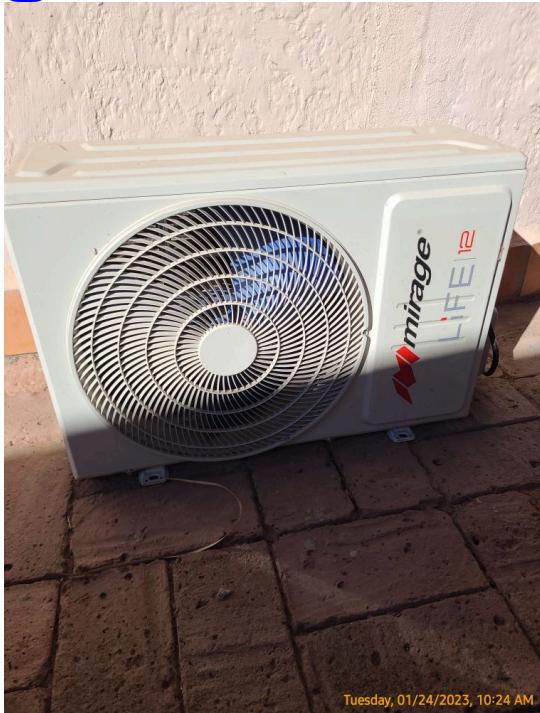
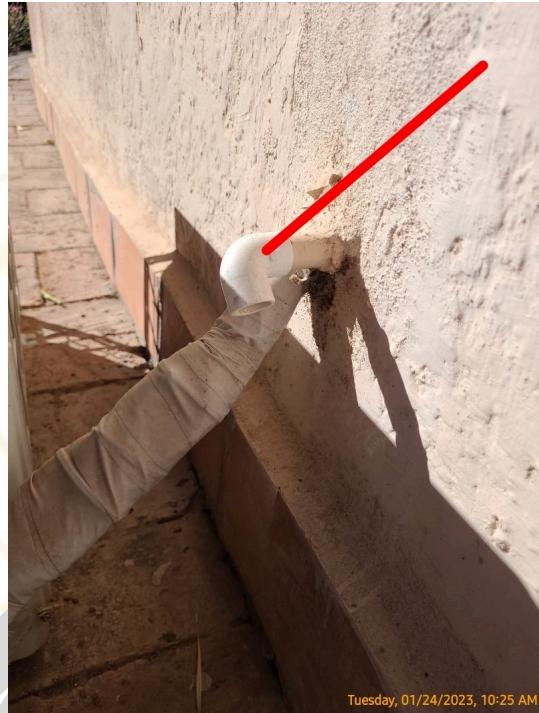
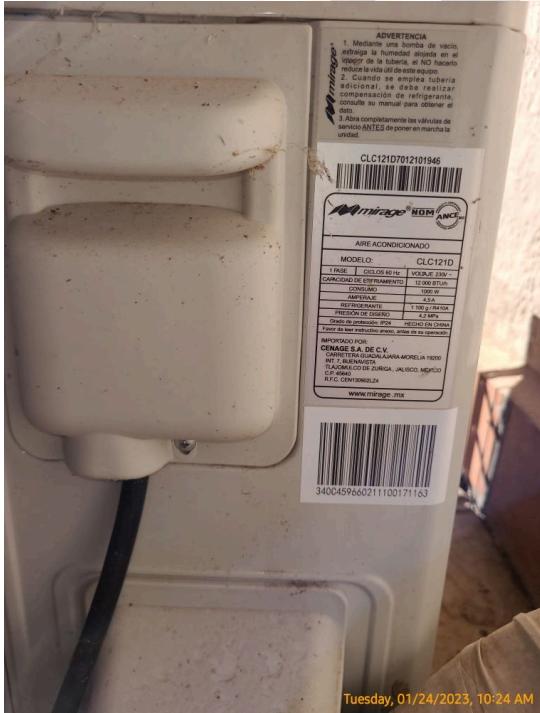
21: Model: Mirage CLC121D

S/N CLC121D7012101946 Recalled [More Info](#)

UPG 30: The air conditioning is newer, responded to normal operating controls and with routine maintenance should be reliable for number of years. The condensation line should be extended so that any liquid is dispersed further from the exterior wall of home.

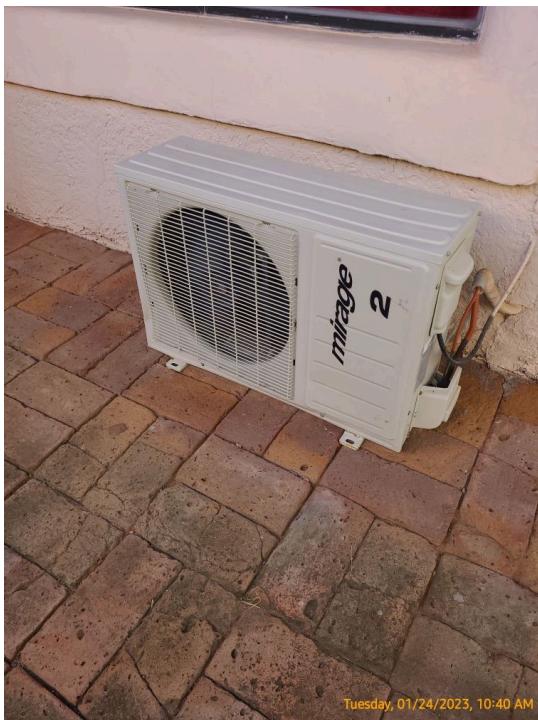
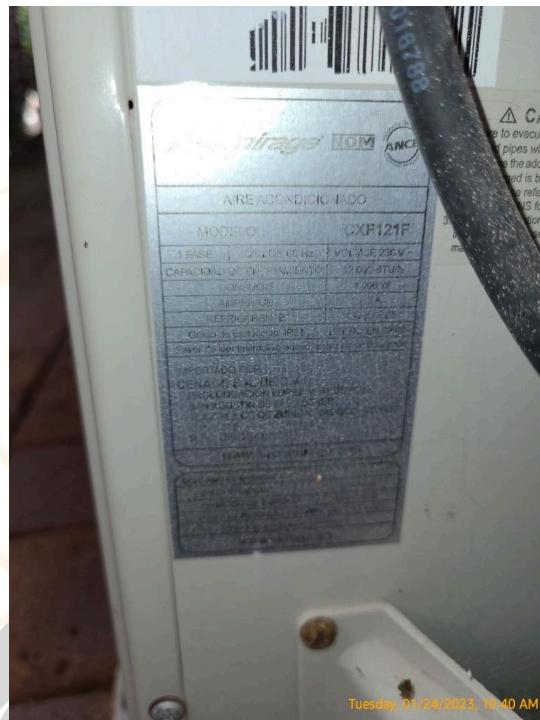
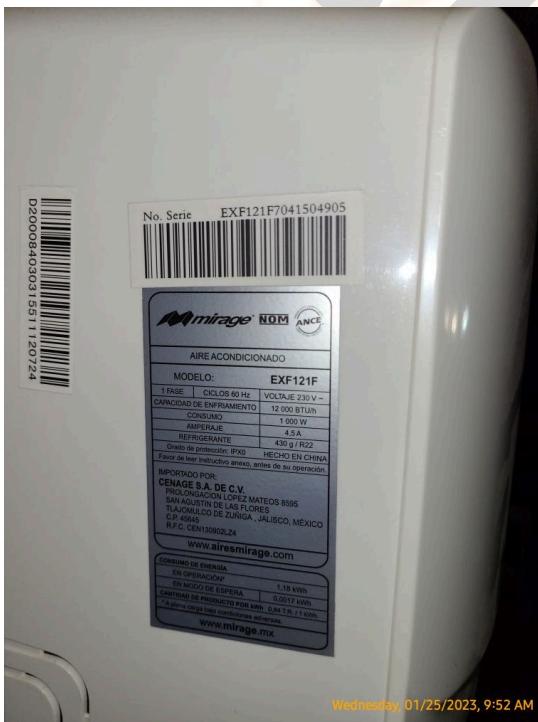
32: Model: CXF121F condenser s/n faded and unreadable

UPG 41: Insulation is deteriorated and missing from a portion of the refrigerant lines near the condensing unit. We recommend that all missing insulation be replaced to increase energy efficiency.

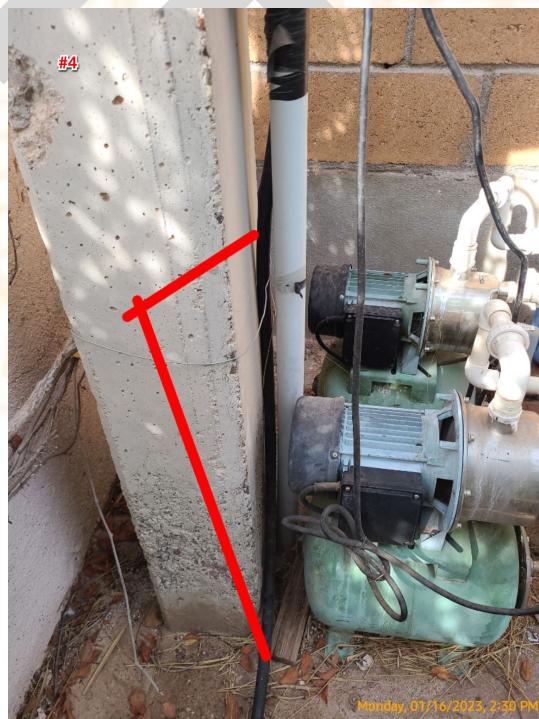
*****Photo #4 Is Of Concern***** At the 50A breaker is an unknown electrical line buried in the ground. Its destination is unknown to the inspector. It is housed in a black poly line resembling .70 drip line commonly used for dripline watering systems INSTEAD of conduit suitable for underground. This should be reviewed by an electrician to determine both the destination & proper conduit suitability.

improper electrical line covering here!! Unknown destination!!

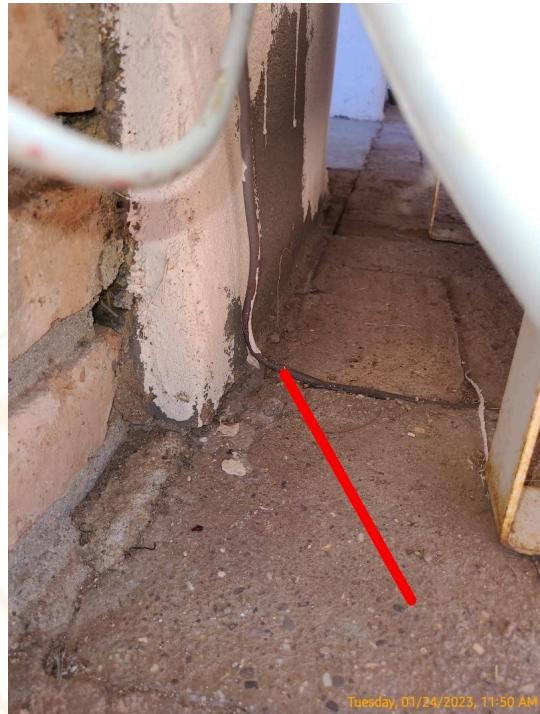
Unprotected gas line entering walkway below tank

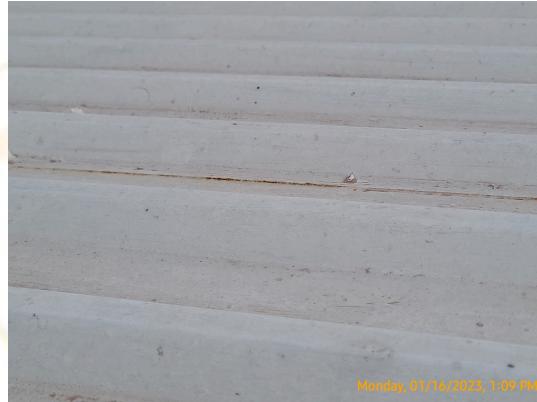
paint appears unblistered w/minimal rust

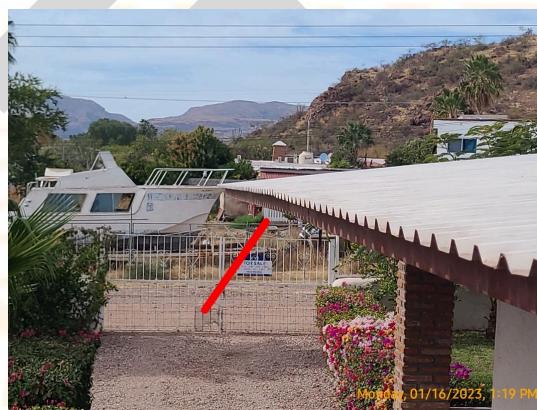
roof line elevation change at weld- non active dip in roof towards front corner

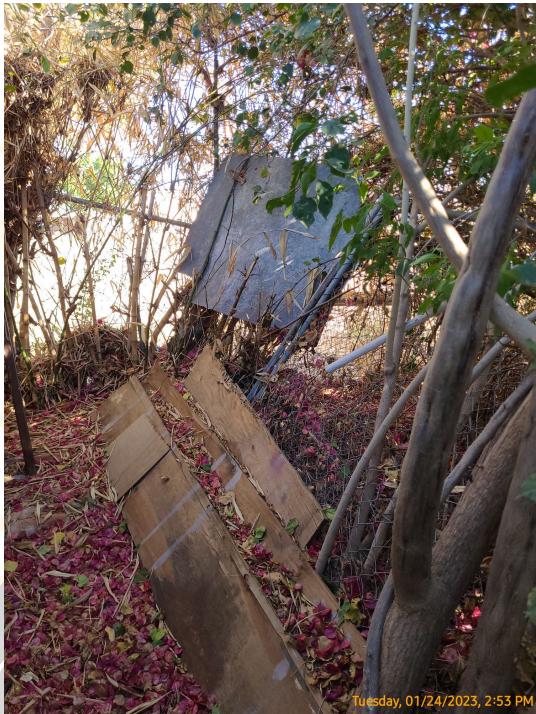
fencing no longer vertical

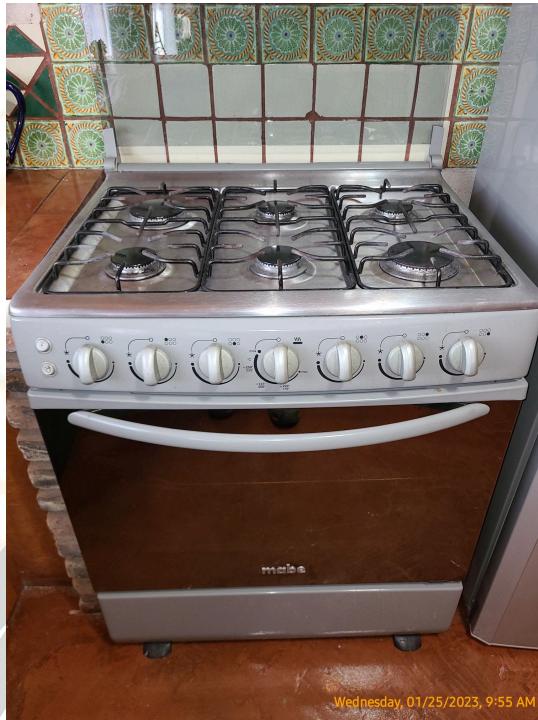
WARN 116: The stove was turned on with the normal operating controls and found to be in satisfactory working condition, with minor exceptions. UNIT does NOT have a tip resistant catch to prevent oven from tipping over.

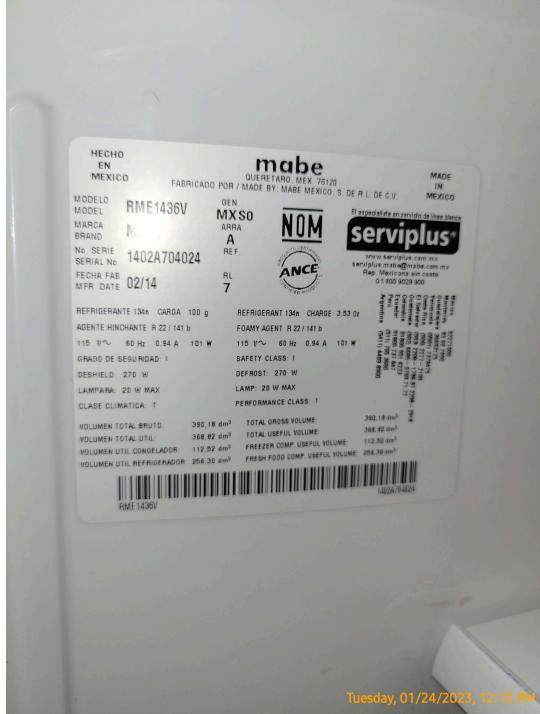
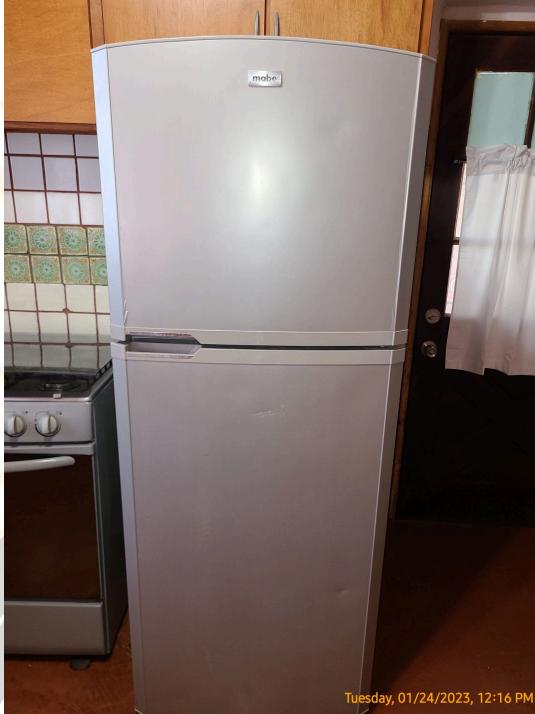
UPG 118: Model: RME1436V
S/N 1402A704024
Date of Manufacture February 2014

Refrigerator is missing of the adjustable feet on the front left location. It is currently on a wood block.

adjusting leg missing/inoperable

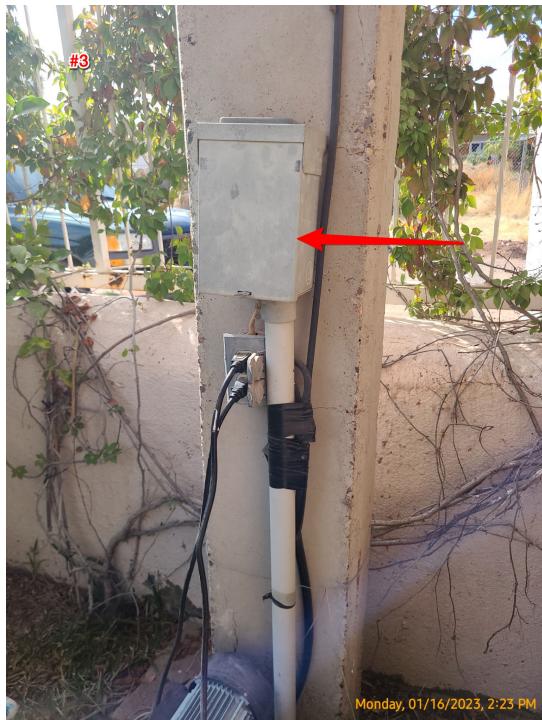
Service drop pole breaker location

1: The meter is located just inside the fence. There is a 50 amp breaker switch for the main power shutoff at the property electrical ingress pedestal. This is normal for construction and electricians methods in this area. The main electrical service panel is outside on the front northwest corner of the building. *****Photo #4 Is Of Concern***** At the 50A breaker is an unknown electrical line buried in the ground. Its destination is unknown to the inspector. It is housed in a black poly line resembling .70 drip line commonly used for dripline watering systems INSTEAD of conduit suitable for underground. This should be reviewed by an electrician to determine both the destination & proper conduit suitability.

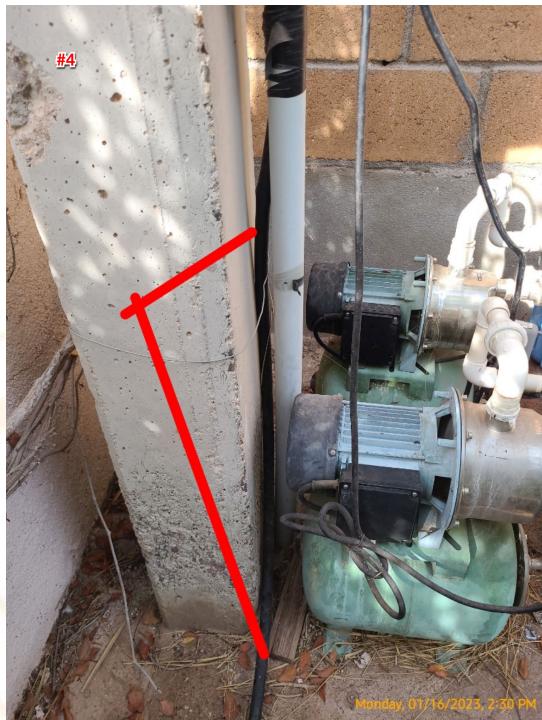
improper electrical line covering here!! Unknown destination!!
